**HOME FARM  
SWINTON GRANGE  
SWINTON  
NORTH YORKSHIRE**

**HISTORIC BUILDING ASSESSMENT**

*September 2018*

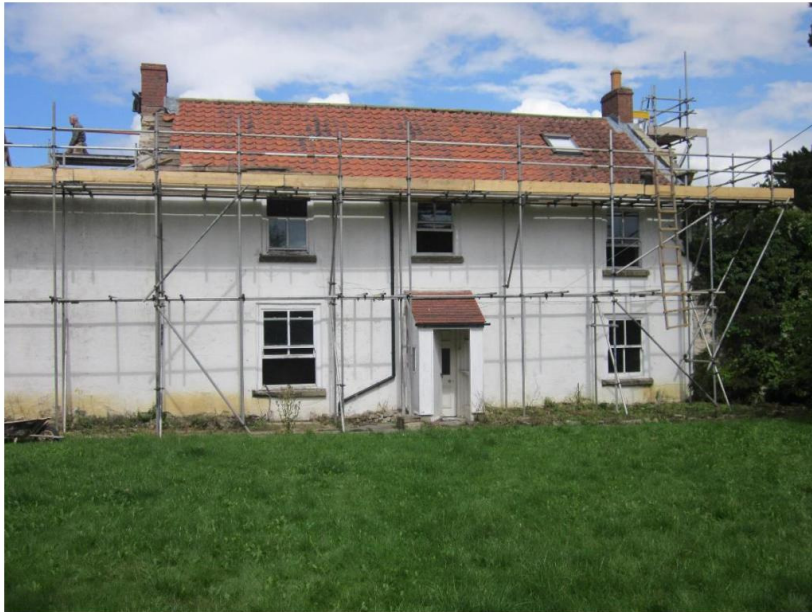
Home Farmhouse is constructed of coursed and occasionally squared limestone rubble with brick dressings. It is of two stories with a small basement and an attic room under a king post roof with double side purlins. The plan is a simple one, typical of its period: there is a main range with the entrance front facing south (Fig 6), and a rear service range. Behind the balanced but asymmetrical south elevation lie two principal rooms with a stair hall between them. A large kitchen takes up the ground floor of the rear range. The first floor plan mirrors that of the ground floor (with inserted C20 bathrooms over the rear range kitchen) while a further flight of the main stair gives access to an east attic room lit by a small sliding sash window in the east gable.

Fig 6 Building 1 South elevation

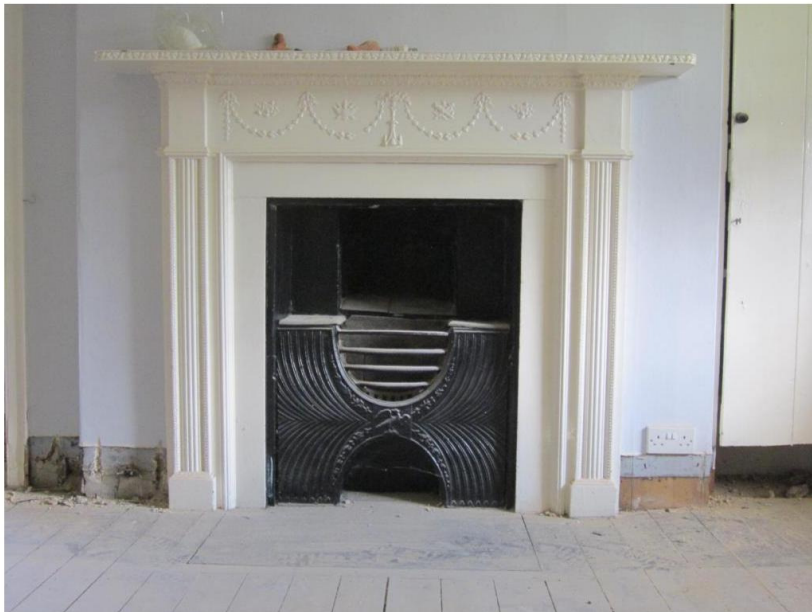
Home Farmhouse retains some stylish internal features including a closed string stair with stick balusters and a delicate turned newel supporting a slender ramped handrail. There are several hobgrate fireplaces (Fig 7; including two Forest pattern hearths), ornamented surrounds, six panelled doors and moulded window architraves. There is a late C19 register-plate fireplace in the south west ground floor room which was plainly the principal room in the house.

Fig 7 Building 1 Forest pattern hobgrate

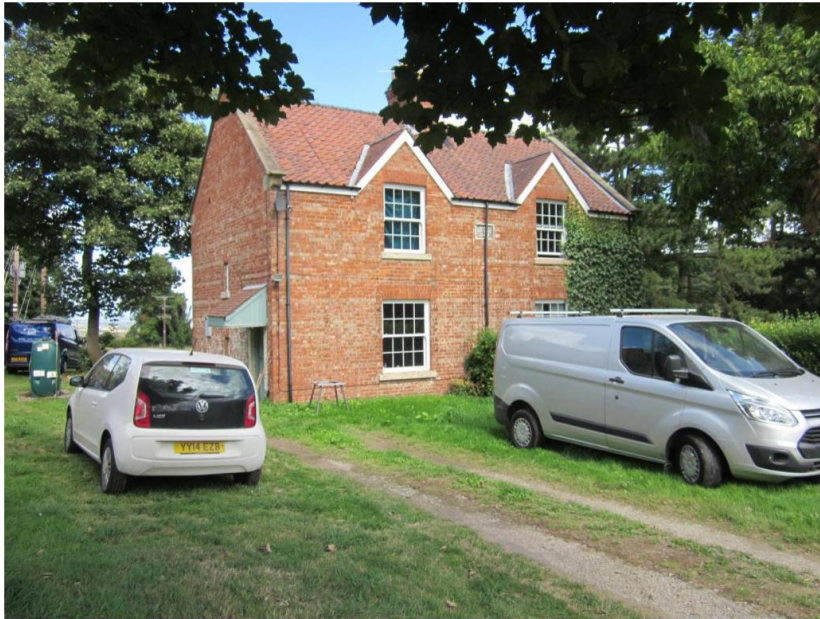
This pair of semi-detached houses was constructed in 1904 on the evidence of a date stone in the centre of the south elevation. The houses are built of red engineering brick (in English garden wall bond 5 + 1) under pantiled roofs with raised, coped gables (Fig 8). The cottages are symmetrically planned: each house has a side door to a stair lobby, beyond which is the front room, the most important room in the house: with a large fireplace to match. There are minor rooms and service rooms to the rear, and in the rear range, and a single central stack serving both properties. The upper floor mirrors the ground floor. There are 16 pane sashes to the principal (south) elevation and some lesser windows and replacement windows to the sides and rear. Internally they were plainly but attractively detailed with tiled floors and register-plate fireplaces. They are set in their own private gardens and were presumably intended for farm managers and their families.

Fig 8 Building 2 Anna Cottages

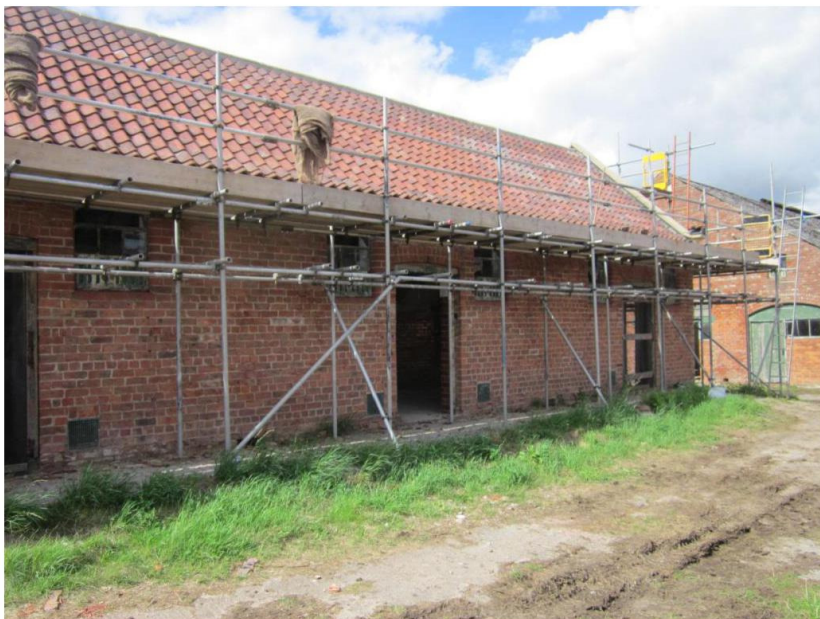
The building formerly held stalls for cattle and was almost certainly a milking shed: an interpretation supported by the use throughout of brown glazed brick in the interior (Fig 10: indicating a new awareness of hygiene and cleanliness) and by the good natural lighting provided by high-level cast-iron framed windows with sliding ventilators. The principal (east) elevation has a symmetrical elevation of three bays, each bay with a door opening flanked by windows (Fig 9). There are oculus ventilation openings to each gable.

Fig 9 Building 3 East elevation

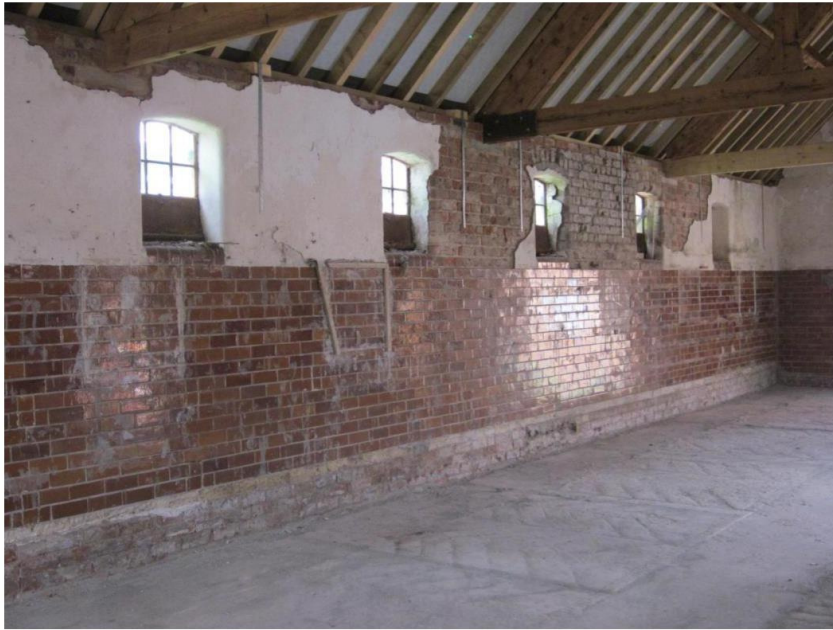
Fig 10 Building 3 Interior

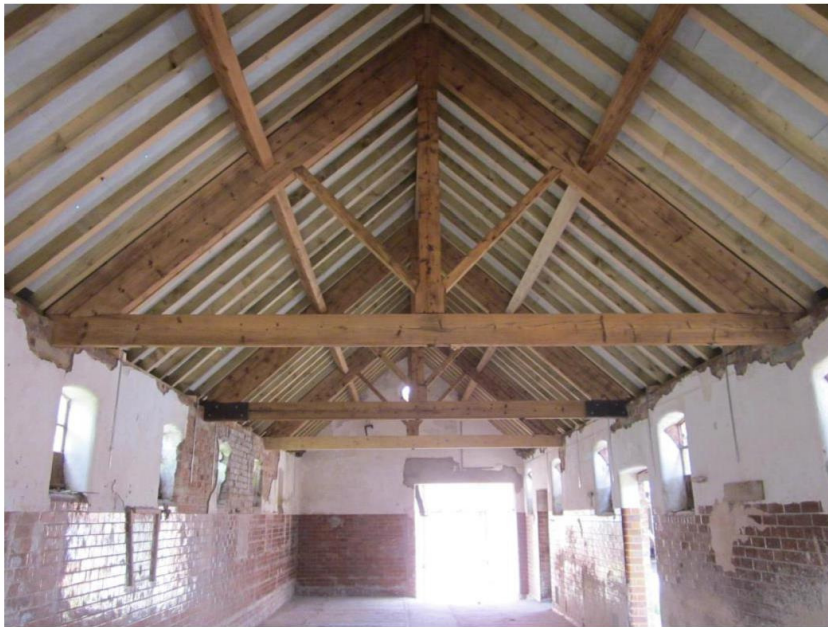
This building aligned north-south is constructed of red engineering brick under a pantiled roof with raised, coped gables. It has bolted king post trusses with side purlins (Fig 11).

Fig 11 Building 3 Roof structure

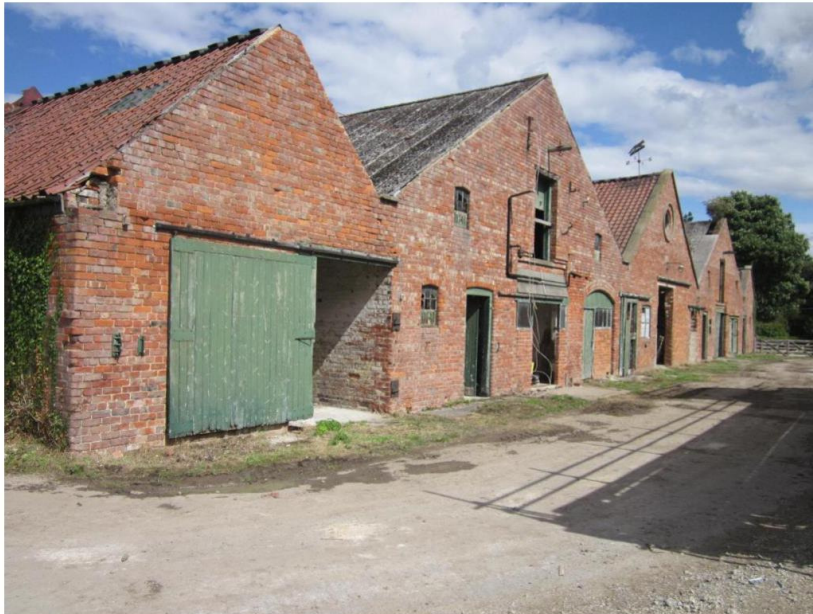
The impressive gabled elevation of the south range (Fig 12) has been slightly disrupted by later alteration but original features survive such as pedestrian doorways with boarded doors on bolted strap hinges and larger openings under segmental heads. At first floor level there are taking in doors with pulley brackets over, and a moulded oculus window in the centre gable reminiscent of those seen in C19 iron foundries and factories. Beneath the window there is a limestone block which seems intended to take an inscription (like that on Anna Cottages) though none is visible now. Below that is a lamp.

Fig 12 Building 4 South elevation

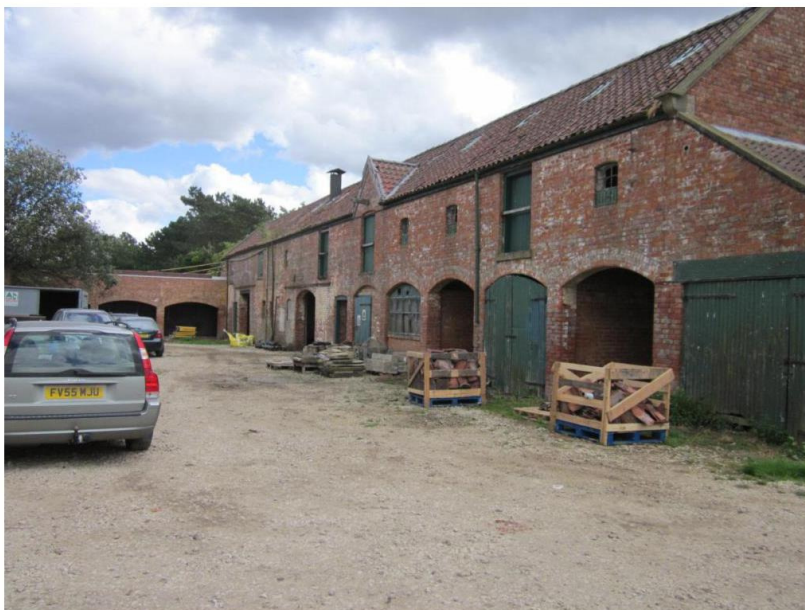
The north elevation of the north range (Fig 13), eleven bays long, is characterised by an irregular arrangement of six (originally seven) wide openings with double boarded doors under segmental brick heads. The seventh opening, at the east end, has been altered but would once have resembled the others. One opening, above the arch, retains a plain iron or steel bar for an original sliding door. The modern replacements elsewhere in the building are of a quite different pattern. On the first floor, again in an irregular arrangement, are boarded taking-in doors and the standard cast-iron ventilator windows used everywhere in this phase. The sliding

Fig 13 Building 4 North elevation

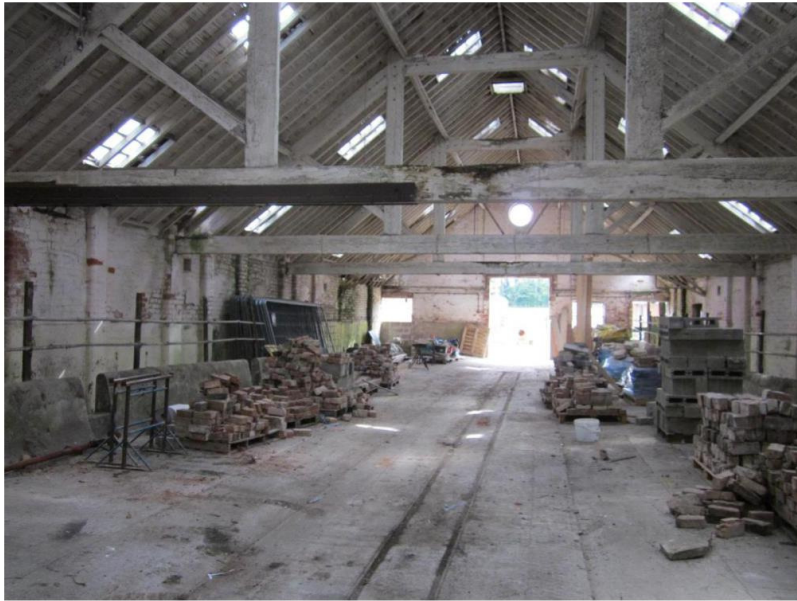
The building is symmetrically planned around a central north-south range with north and south cross ranges and end ranges. The central range is a large covered cow shed (Fig 14) and was originally flanked by open yards to east and west (Fig 15). The north range was used for feed processing with feed storage on the first floor (Fig 19); the south range for a variety of mixed purposes but latterly for dairying (see below); the east range for stabling and later for calf pens (Fig 18); and the west range perhaps for storage and further workshops (Fig 16). A short rear wing at the east end of the north elevation is a wagon shed while the westernmost bay of the north range houses a blacksmiths' shop. Three major openings exist in the north range allowing independent access for livestock to the central shed and the flanking east and west yards.

The large covered shed at the heart of Building 4 has a five-bay roof of bolted queen-post trusses with raked struts to double side purlins (Fig 14); the ends of the tie beams are carried on internal pilasters. However the south truss has been replaced with a truss of electrically-welded L-section steel while the north truss has been flitched with bolted steel plates: both repairs were probably a consequence of the great span of the shed.

Fig 14 Building 4 Covered cowhouse with axial railway track

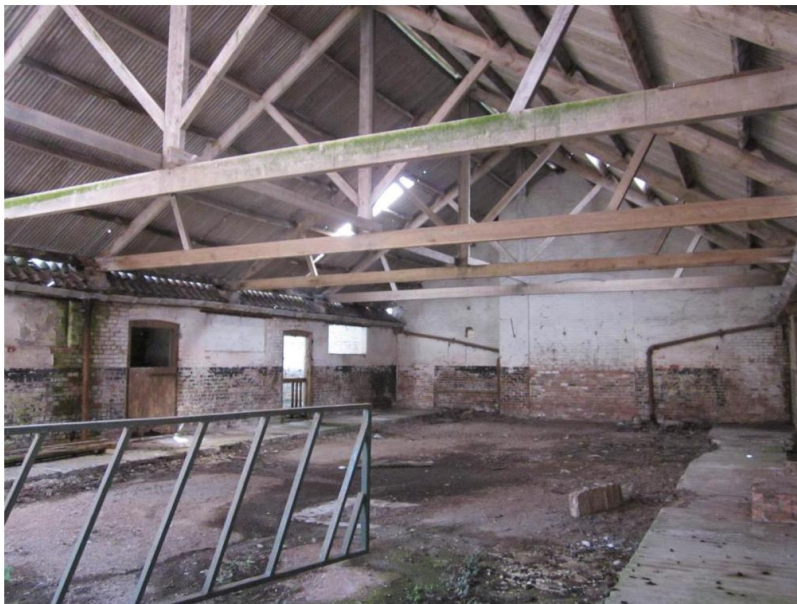
The south range has probably undergone more changes of use and alteration than the other areas of the building. At some point in the later C20 the external yards to east and to west of the central covered cow house were roofed over using profiled sheeting on slender king post trusses. The ties are carried on heightened brick pilasters raised on the walls of the adjoining Phase II sheds. It appears that to make life easier for the builders the old pantiled roofs over the south range were removed and the gables probably adjusted to a new pitch; then the profiled sheeting roofs were simply carried straight over the earlier south range instead of making an awkward butt joint against the rear wall. The rooms and working spaces of the south range are now largely taken up with obsolete dairying equipment; some areas are tiled out to take modern plumbing. There are no indications of their original use except in the easternmost bay which has been used as a loose box with manger.

Fig 15 Building 4 East yard covered in late C20

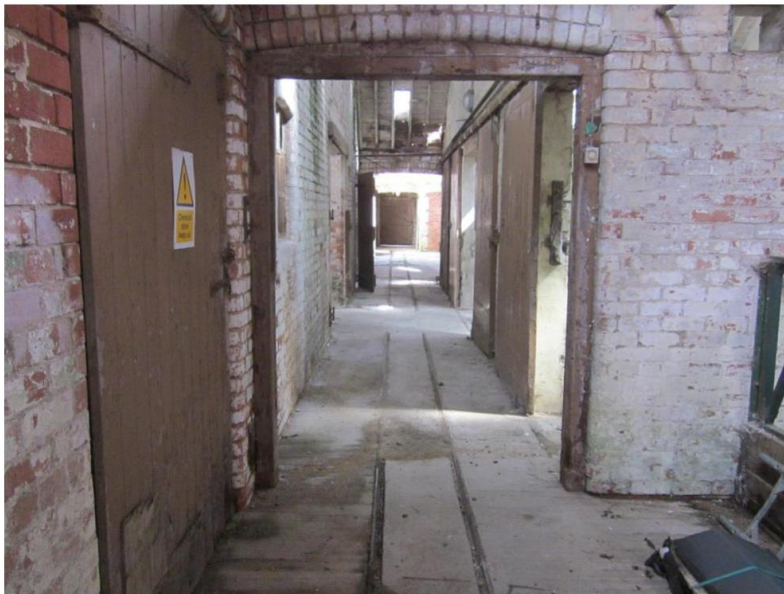
An important feature of the building is a narrow-gauge railway (Fig 17). One track runs alongside the south elevation of the north range (allowing trucks to be filled with feed) while the other lies on the main north/south axis of the central covered shed. Presumably at the junction of the two there was a turntable, although this has now been lost or buried. The main north/south track passed through the north range and into the yard beyond, where it has been lost. It is these tracks, together with the plan form of the buildings they serve, which more than any other feature mark Home Farm out as a natural descendant of the model farms designed and built along industrial lines in the mid C19. The northward extension of the main track into the yard was to allow removal of manure, the production of which was also regarded as an integral function of these buildings.

Fig 17 Building 4 Railway track to south of north range

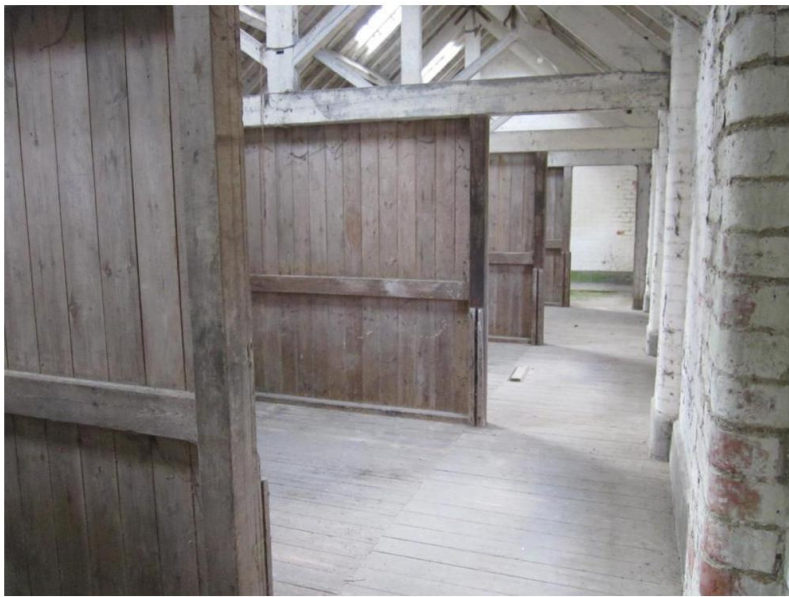
Fig 18 Building 4 East range interior

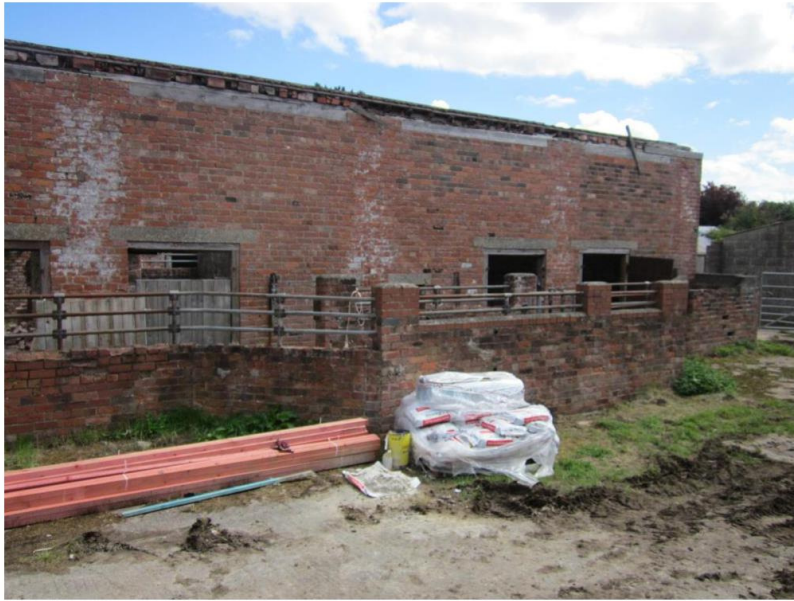
Building 5 is a range of four large pigsties: each with a small external yard to the east (Fig 21). The range is of red brick and has a monopitch roof covered with pantiles. The building is in very poor condition and has partially collapsed. In the west elevation there are wide openings under concrete lintels alternating with small feed chutes serving concrete food troughs protected by steel bars. The arrangement appears to be a late C20 transformation of the original one but the degree of dilapidation and collapse makes interpretation difficult. Pig movement in the area to the west of the sties appears to have been controlled by a system of low brick walls incorporating steel bars and a baffle (Fig 20).

Fig 20 Building 5 West elevation of pigsties

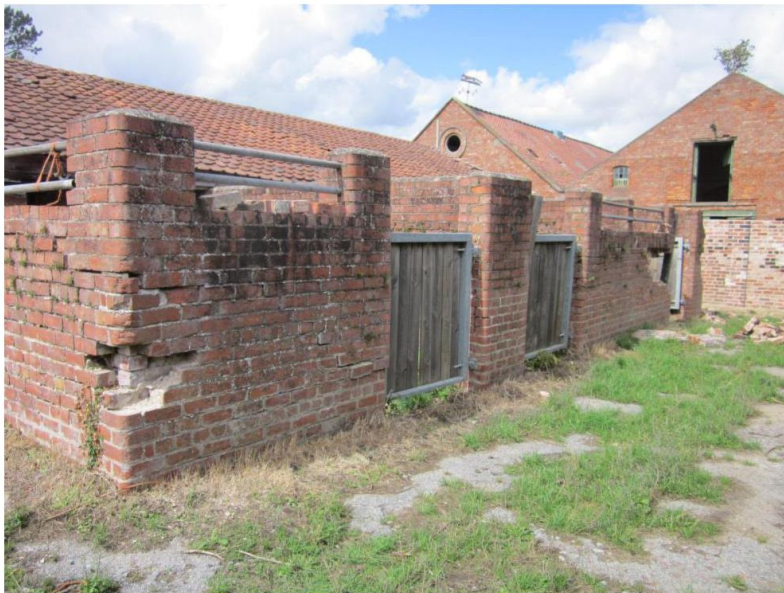
Fig 21 Building 5 East elevation of pigsties

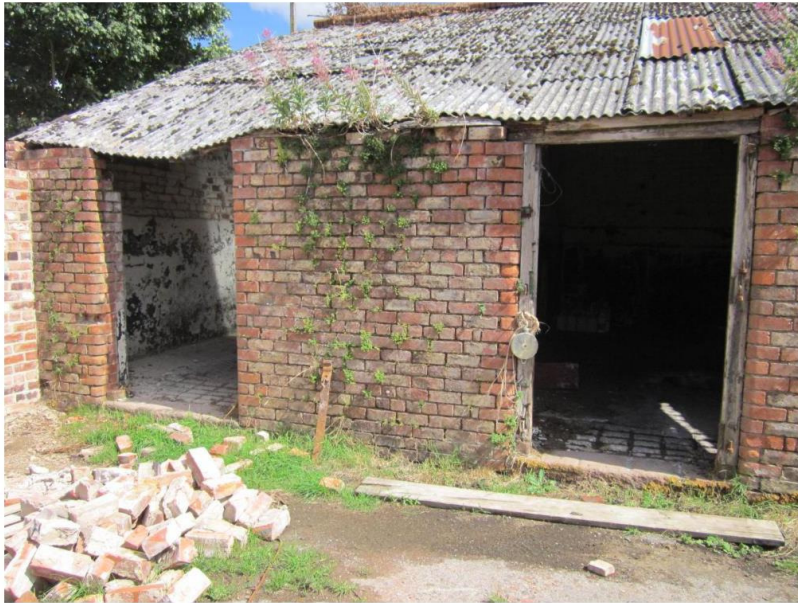
Building 6 is a simple two bay shed of red brick under a later profiled sheeting roof. Its original function is unknown but it may have contained loose boxes (Figs 22, 23).

Fig 22 Building 6 West elevation

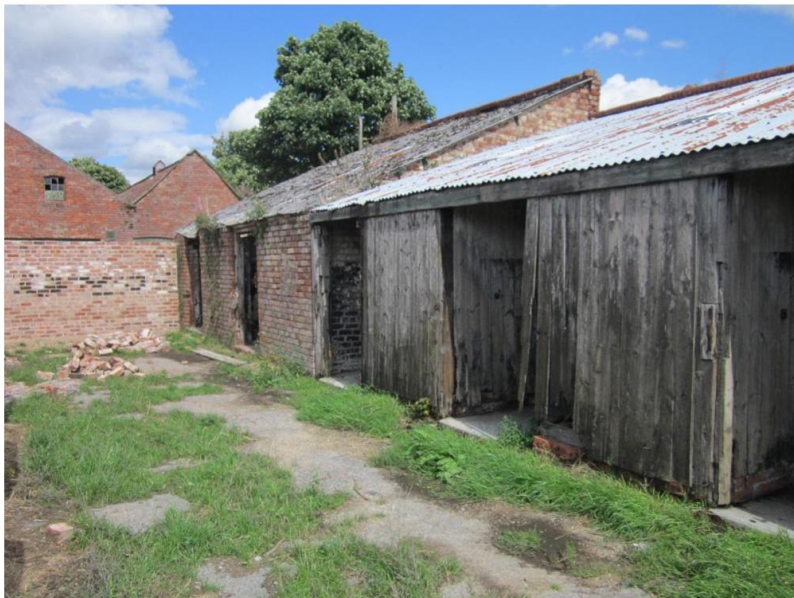
The two principal ranges of timber sheds extend to the south of Buildings 5 and 6 respectively (Fig 23). Buildings in these positions are shown on the 1911 OS and it is possible that the existing sheds were indeed constructed in Phase II. The eastern range makes use of the west wall of the courtyard to Home Farmhouse to support a monopitch roof. To suit its new purpose this wall was raised in the usual Phase II red brickwork and each bay of the shed given a six-pane light under a segmental brick head.

Fig 23 Building 6 and timber sheds to south

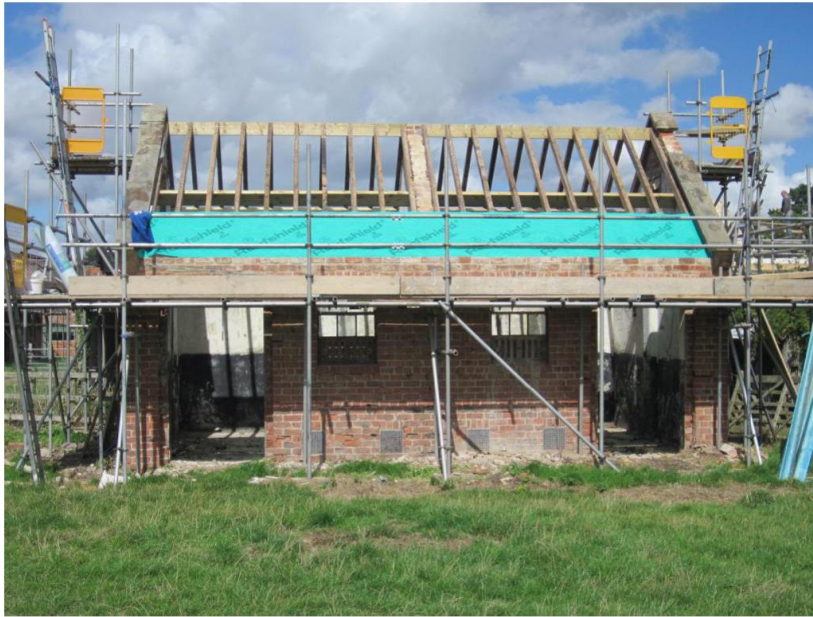
This is also a two bay shed but one constructed to a higher standard than Building 6 (Fig 24). It is of red brick under a pantiled roof with raised, coped gables and contains two loose boxes, both of which retain iron tethering rings let into the brickwork.

Fig 24 Building 7 South elevation

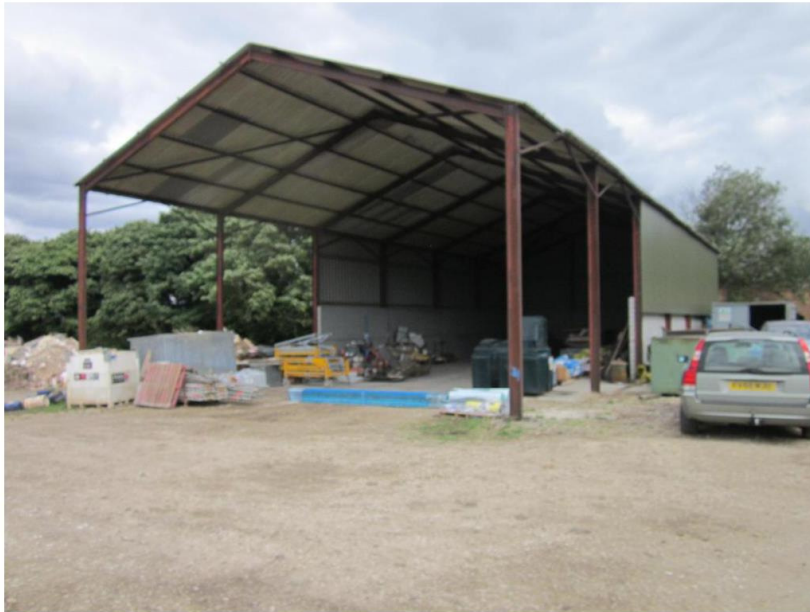
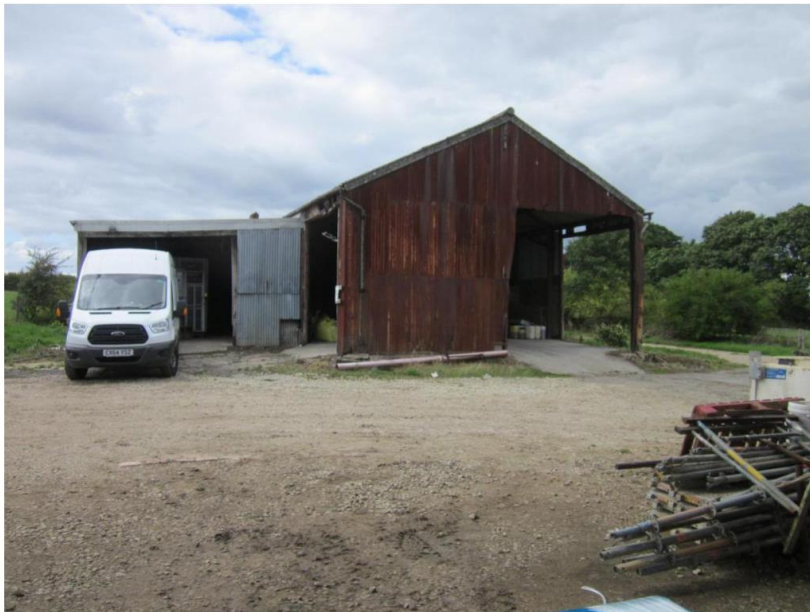
There are two of these to the main block (Building 4). Each lies on the site of an earlier structure shown on the 1911 OS sheet but now demolished (Figs 26, 27).

Fig 26 C20 steel-framed north-east shed

Fig 27 C20 steel-framed north-west shed
