1a. Restoration plan overview

Client: Environment Agency
Project: Derwent Straightening
Title: Restoration plan and expected changes in bed topography

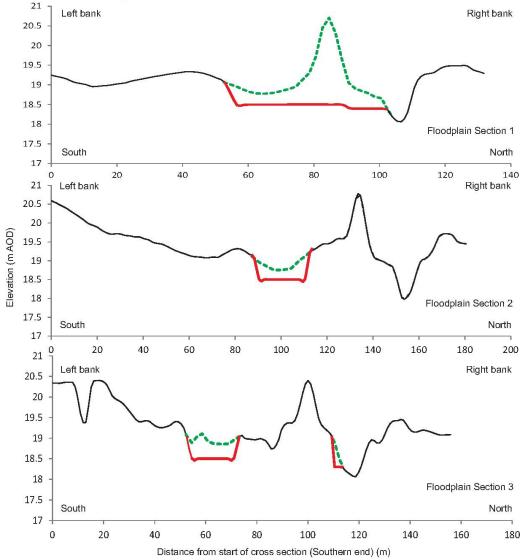
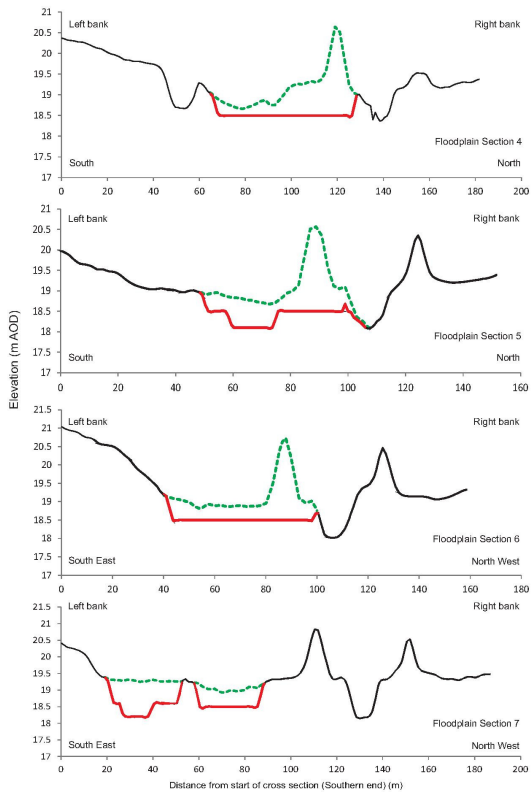
## 2b. Derwent floodplain cross sections

**Legend**  
— Unmodified  
--- Existing section (pre-restoration)  
— Modified section (post-restoration)

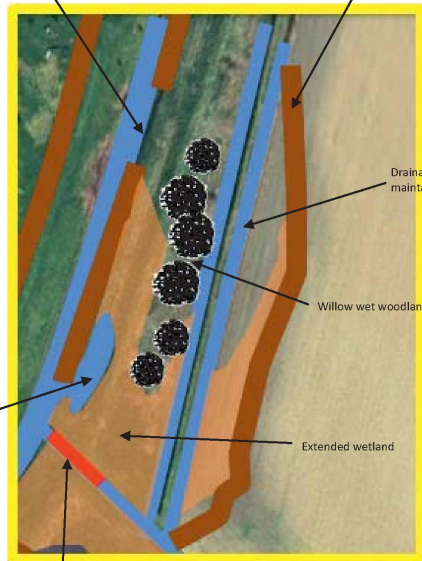
#### 5c. Upstream restoration overview

Embankment breached to allow flood water rapidly back into the Derwent after a flood

Connected backwater (piped to allow access)

Existing culvert to be retained

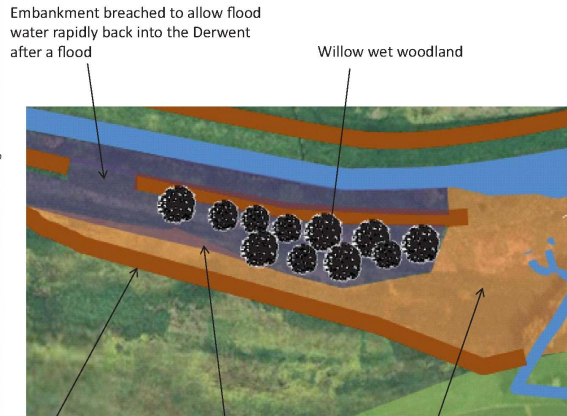
#### 8b. Downstream restoration overview

New embankment using arisings to limit flood extent  
Extended wet grassland(similar to present)  
Extended wetland
