Proposed Extension	
Glebe Farm Barn, Flaxton	
Proposed Elevations	
Rev A	June 2014
Scale 1:50

Proposed Extension	
Glebe Farm Barn, Flaxton	
Proposed Elevations 2	
Rev A	June 2014
Scale 1:50

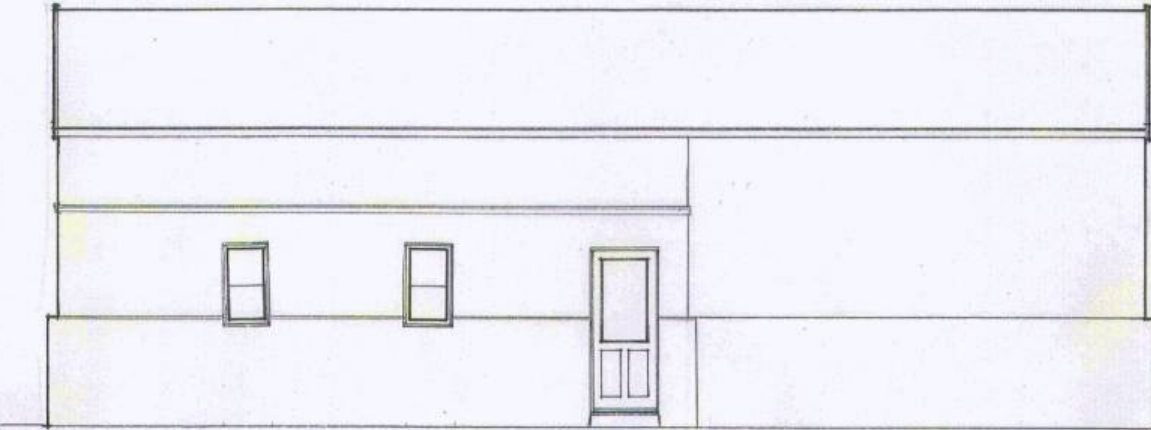
SOUTH ELEVATION

ROOF TO MATCH EXISTING CORRUGATED SHEETS
WALLS CLAD IN VERTICAL SW BOARDING, RED RUSTIC BRICKS TO FLINTH TO MATCH EXISTING
UPVC GUTTERING IN BLACK 112 DIA
UPVC WINDOWS AND DOORS

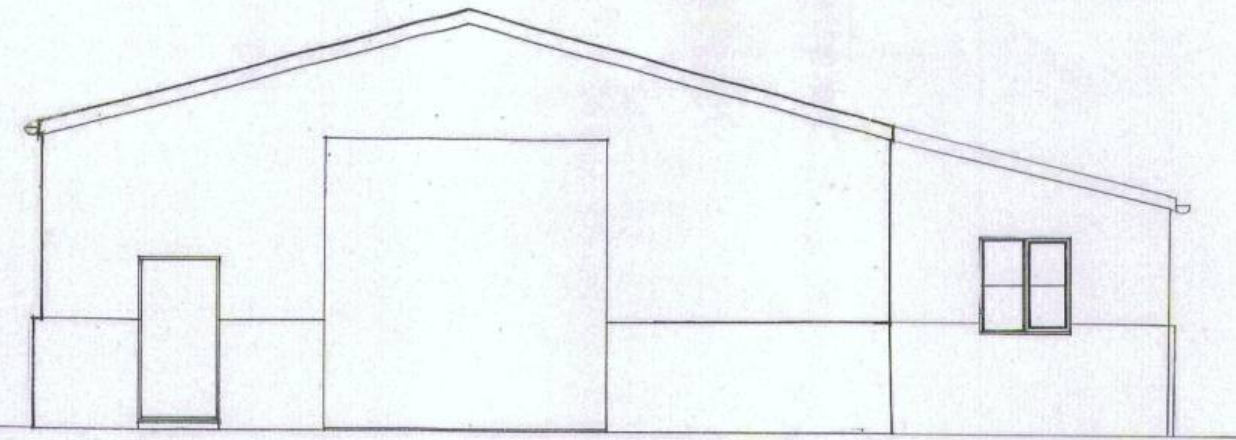
WEST ELEVATION

ROOF TO MATCH EXISTING CORRUGATED SHEETS
WALLS CLAD IN VERTICAL SW BOARDING, RED RUSTIC BRICKS TO PLINTH TO MATCH EXISTING
UPVC GUTTERING IN BLACK 112 DIA
UPVC WINDOWS
