Malton War Memorial Restoration Committee

Felling Application No. 17/00504/CAT
Tree Preservation Order No. 346/2017
Planning Application 15/01093/FUL

Tree Preservation Order at Malton War Memorial

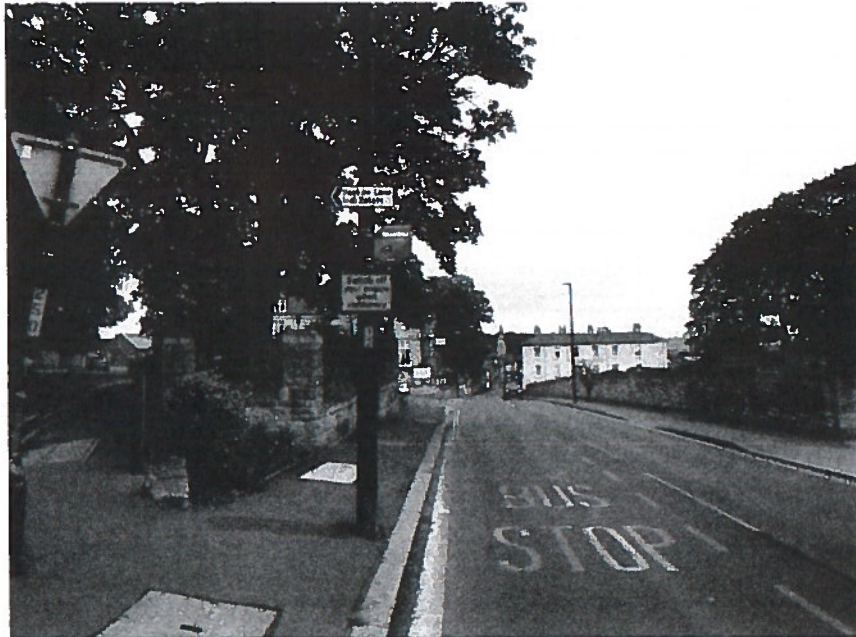
The tree roots are lifting the paving slabs behind the Memorial leaving the area unsuitable for wheelchairs and a trip hazard. The railings were removed during World War II and there is a potential fall of about 3 feet at the south east corner.

The tree overhangs the road on either side and is a potential source of damage to high-sided vehicles on one of the main routes into the town.

Tree Overhanging Yorkersgate and Horsemarket Road

The tree is an existing nuisance for the reasons given in paragraph 3. There is the potential to replace the tree with a smaller species which will not interfere with passing traffic nor obscure the Memorial.
